Our Corner Saloon
301 1st Street
Eureka
Humboldt County
California

HABS No. CA-2684

WRITTEN HISTORICAL AND DESCRIPTIVE DATA

OUR CORNER SALOON

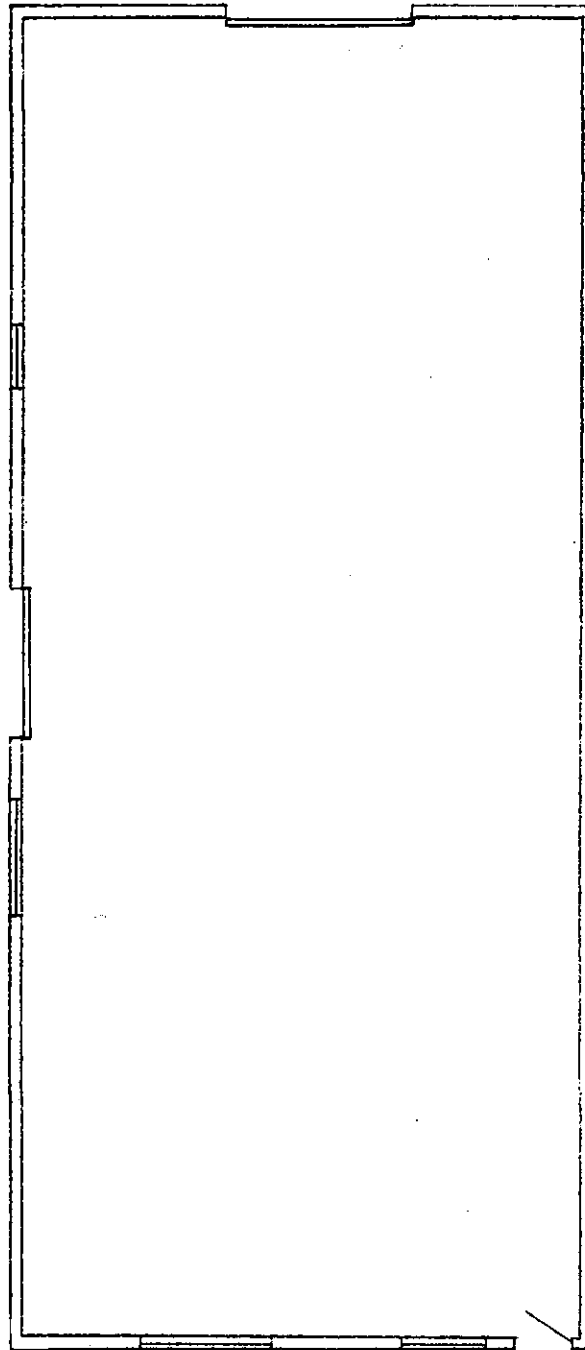
FLOOR PLAN

Interior: The interior of the Our Corner Saloon building is virtually gutted, and is largely a single open space, with a

recent partial loft built in at the south (front) end of the building, and a partial office space at the southwest corner. There are remnants of original horizontal plank walls, mixed with remnants of various dimensions of vertical, beaded tongue-and-groove finish materials from various periods and alterations. The largely beaded tongue-and-groove ceiling likely replaced a plank ceiling. The structure's broad plank floor remains. Perhaps the most historically significant and interesting interior element is stenciling on the remnants of original lath-and-plaster south and west walls.
